# Middle Fork Payette River GRAIP Watershed Assessment USDA Forest Service, Boise National Forest

September 2013

## Middle Fork Payette River Road Inventory (GRAIP) Report Boise National Forest

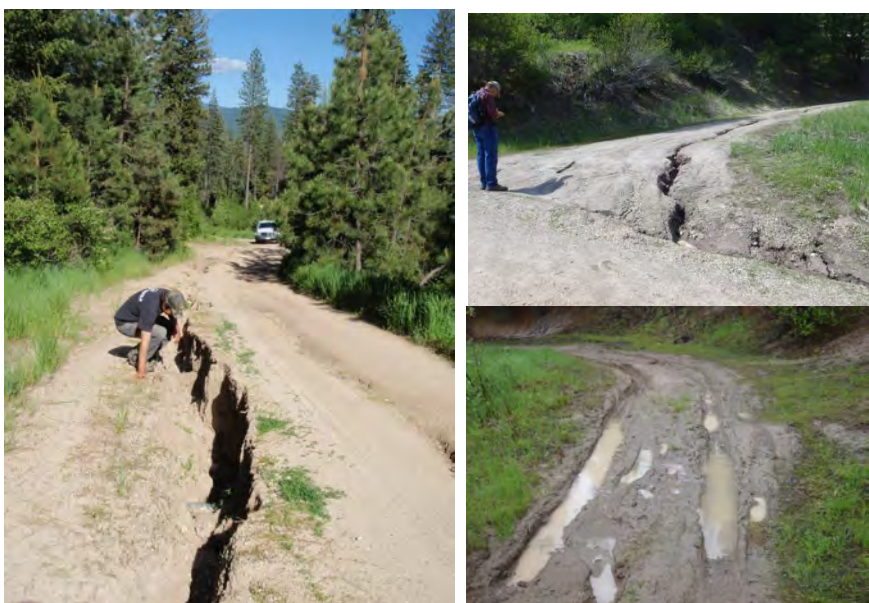
**Photo 3.** *Left:* Matt Taylor inspecting a gullied road surface on Rd 695F. *Top right:* Jim Bitzenburg surveying a waterbar road 695A. *Bottom right:* Saturated and rutted road surface of FR 695A.

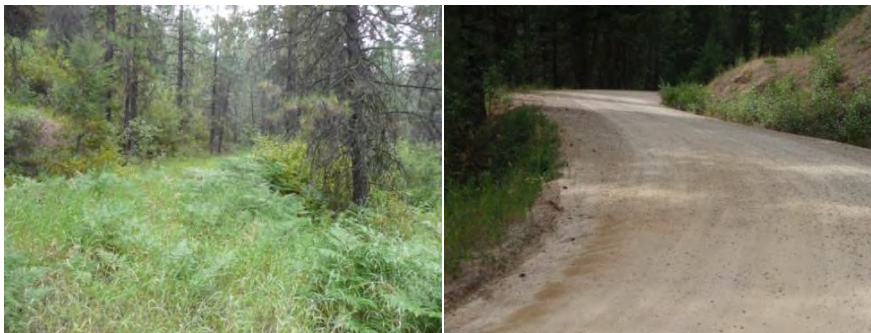
**Photos 4.** The two photos above represent two different road surface types found within the Scriver Creek sub-watershed. *Left:* Herbaceous vegetation surface on FR 695E1. *Right:* Thin layer of crushed rock surface remaining on FR 693.

Vegetation in the flow path, whether a road side ditch, the road surface, or both, is taken into account by the GRAIP model. When the flow path vegetation is observed by the field crew to be greater than 25%, the sediment production rate (amount of sediment eroded off of the road's surface) decreases by a factor of 7. In the Middle Fork Payette Sub basin, 49% of the total flow path length (equivalent to road length) was recorded to have greater than 25% vegetation cover. Relative to other studies and GRAIP road inventories, this figure is rather high. For example, roads inventoried in Bear Valley in 2009 were observed to have greater than 25% vegetation cover in only 27% of total flow path length (Fly et al., 2010). Frequent flow path vegetation can likely be attributed to a high concentration of Maintenance Level 1 roads. Many of these roads have not been graded or otherwise maintained for years, allowing grass, brush, and trees to grow in ditches and on road surfaces. This vegetation has, in many cases, stabilized erosion rates and reduced the impact of chronic sedimentation to streams. However, historic road prisms still pose potential threats to water quality due to risks associated with hillslope and stream crossing failures because old road prisms can intercept and alter surface and subsurface hydrological flow paths and initiate mass wasting events.

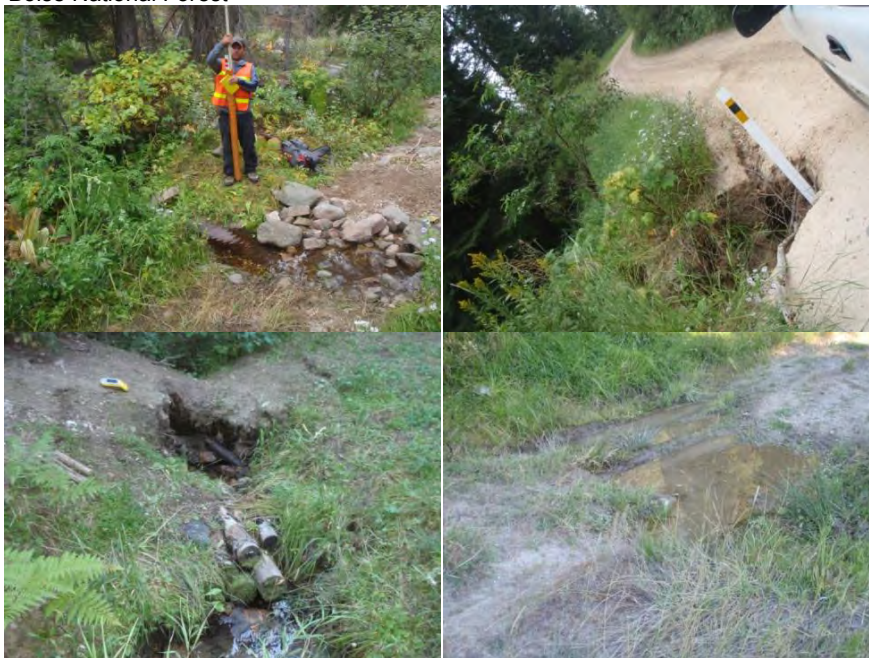
The GRAIP inventory involves an assessment of the condition of each drain point and a determination of how well it is performing its intended function. Problems with drain point condition are pre-defined for each drain type. Broad based dips are considered to be in poor condition if they are insufficiently outsloped and pond water on the road. Culverts are defined to be in poor condition if they have more than 20% occlusion of the inlet by sediment, substantial inlet crushing, significant rust, or flow around the pipe. Lead off ditches are considered problematic if they have excess deposition or are gullied. Non-engineered features are almost always a problem because they were not designed nor intended to exist. For this exercise, they are considered a problem when caused by a blocked ditch, a gully, a broken outside berm, or a diverted wheel track. They were not evaluated to be problematic when they occurred where a road was outsloped. Stream crossings are considered a problem if they are blocked by sediment or wood, crushed or rusted significantly, incising, scouring or loosing much water from flow around the pipe. Sumps are a problem if they exist unintentionally and pond water on the road surface or cause fill saturation. Water bars that are damaged, under sized, or do not drain properly are defined as problematic. Diffuse drains (outsloped roads) are rarely observed to have drain point problems.

**Photos 5.** The photos above demonstrate condition problems associated with road drainage infrastructure that exist within the Middle Fork Sub basin. *Top left:* Scott Bergendorf taking measurements at a stream crossing in the Bull Creek Sub watershed that has diverted over the top of the culvert. *Top right:* Fill erosion at a non-engineered drain point on FR 695. *Bottom left:* Fill erosion and infrastructure failure of a log culvert stream crossing on FR 696A. *Bottom right:* Puddles on road and fill saturation at a broad-based dip on FR 693C.

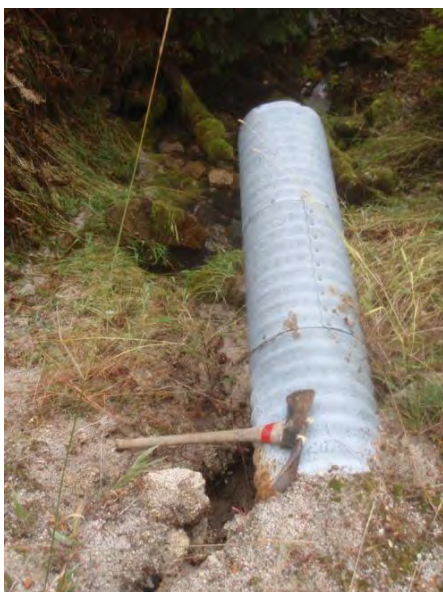
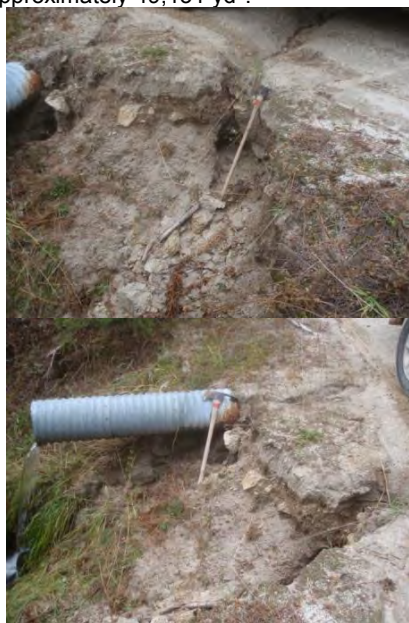
**Photo 6.** The three photos above depict a failed stream crossing that where Scriver Creek crosses FR 694 near the headwaters. This crossing showed evidence of being plugged and causing water to flow over the road. This past event (or possible recurring event) eroded away a large amount of fill material, washing it down the channel. The 15 inch diameter pipe is undersized for the estimated 4 foot wide channel at high flow. GRAIP predicted the SBI at this stream crossing to be 3.

A second, and perhaps greater, consequence of concern at failed stream crossings is the diversion of stream flow onto road surfaces and unchannelled hillslopes. Once a crossing becomes occluded and begins to act as a dam, failure can occur in several ways. If the road grade dips into and rises out of the crossing, the failure is likely to be limited to a localized overtopping of the stream crossing. However, if the road grades away from the stream crossing in one or more directions, the flow may be diverted down the road and ditch and onto adjacent hillslopes, where it can cause gullying and/or landsliding (Furniss et al. 1998, Best et al. 1995). This was observed within the Scriver Creek sub watershed during the spring of 2012. A rerouted stream crossing diverted down the 695 road causing slope failure below the road and initiated a debris flow in Hidden Creek that traveled several miles down Scriver Creek depositing a substantial amount of material.

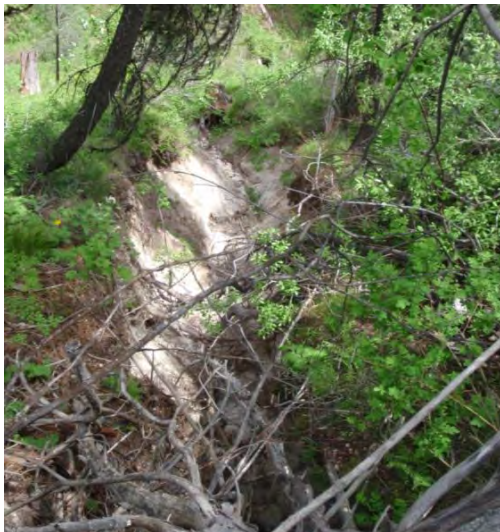
Gullying of fill and hillslope material below drain points can be a substantial source of sediment to stream channels. A gully was defined as a linear erosional feature at least ten feet long and six inches deep. 199 gullies were mapped below drain points, not including road and ditch segments that had gullied segments. 187 of the gullied locations were clearly related to road runoff and had mobilized 13,575 cubic yards of material. 13 of these were observed to have stabilized and were no longer actively eroding. 12 gullies were observed to have been caused by hillslope water and mobilized 4,767 cubic yards of material. No estimate of the amount of gully material delivered to the channel was made.

**Photo 7** (Left) Gully west fork Scriver Creek on 696, this gully is estimated to have 45 cubic feet of erosion and is still actively eroding. *Right:* Two merging gullies on ridge top road 689L5. The feature on the lower left is one of a number of gullies located on the 671 road above Trail Creek.

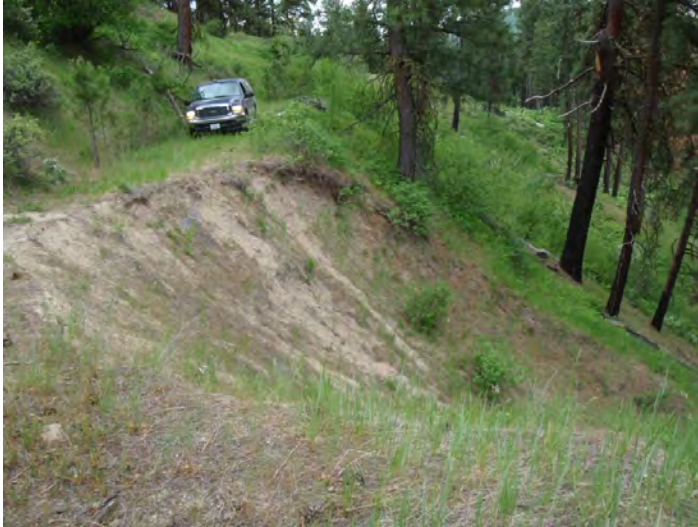
**Photo 8.** Large landslide of fill slope on a spur road off of 669.

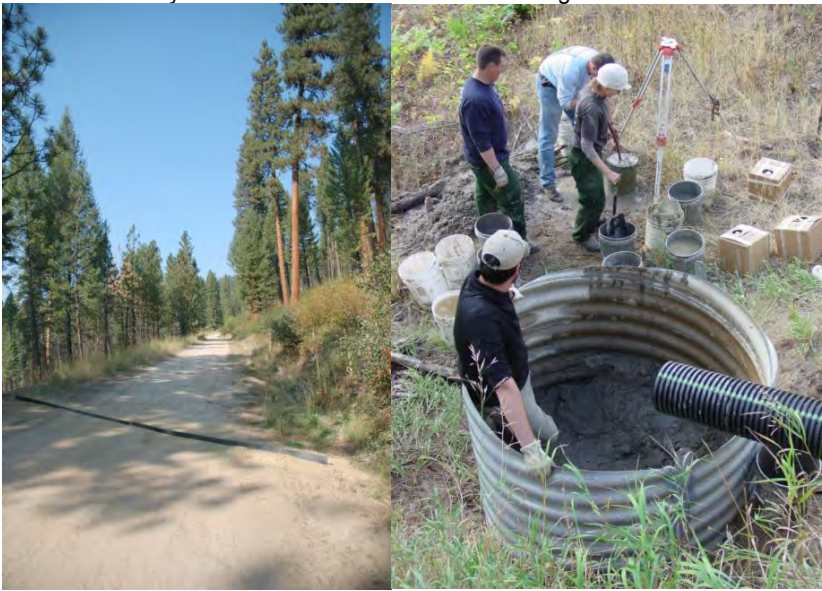
**Photo 9.** Typical road plot on left and sediment tank on the right.

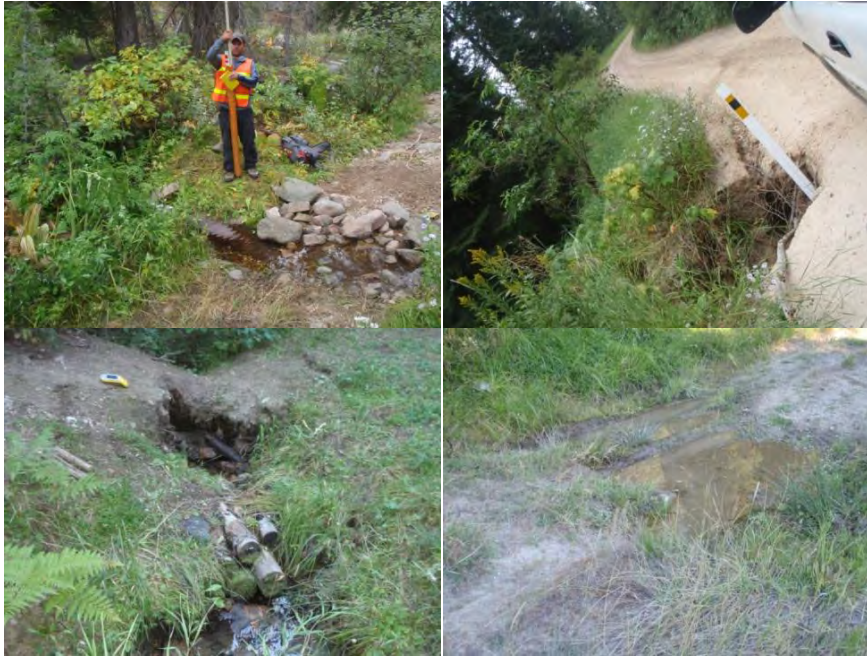
**Photos 5.** The photos above demonstrate condition problems associated with road drainage infrastructure that exist within the Middle Fork Sub basin. *Top left:* Scott Bergendorf taking measurements at a stream crossing in the Bull Creek Sub watershed that has diverted over the top of the culvert. *Top right:* Fill erosion at a non-engineered drain point on FR 695. *Bottom left:* Fill erosion and infrastructure failure of a log culvert stream crossing on FR 696A. *Bottom right:* Puddles on road and fill saturation at a broad-based dip on FR 693C.

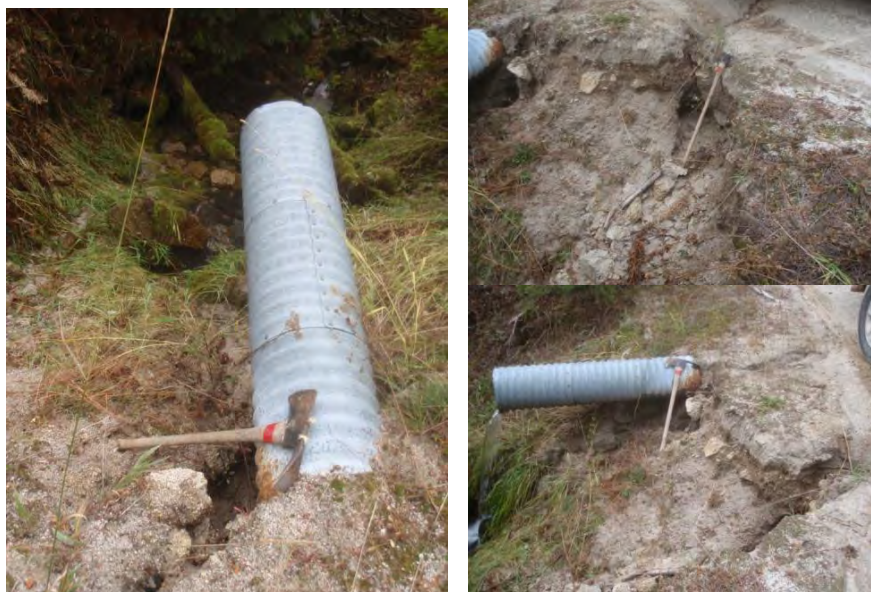
**Photo 6.** The three photos above depict a failed stream crossing that where Scriver Creek crosses FR 694 near the headwaters. This crossing showed evidence of being plugged and causing water to flow over the road. This past event (or possible recurring event) eroded away a large amount of fill material, washing it down the channel. The 15 inch diameter pipe is undersized for the estimated 4 foot wide channel at high flow. GRAIP predicted the SBI at this stream crossing to be 3.

The risk of a stream crossing failure can also be viewed in the context of the consequences of failure (Flanagan et al. 1998). A consequence of concern at these stream crossings is the erosion of fill material into the stream channel. The fill material that would likely be excavated in an overtopping type failure was calculated. The prism of fill at risk was modeled as bounded at the base by an area 1.2 times the channel width, with side slopes climbing to the road surface at an angle of 33%. The fill volume at the 527 stream crossings with pipes was approximately 49,131 yd<sup>3</sup>.

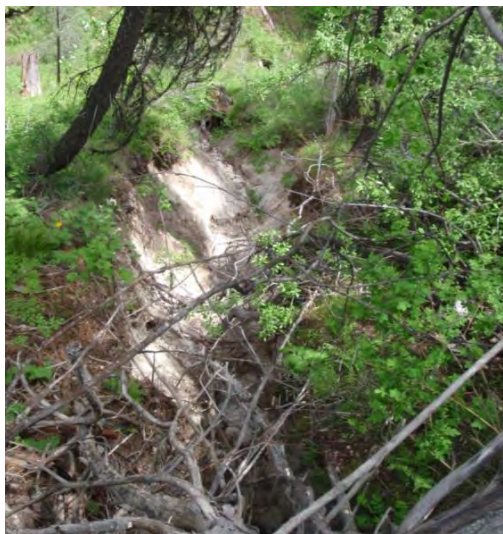
**Photo 7** (Left) Gully west fork Scriver Creek on 696, this gully is estimated to have 45 cubic feet of erosion and is still actively eroding. *Right:* Two merging gullies on ridge top road 689L5. The feature on the lower left is one of a number of gullies located on the 671 road above Trail Creek.

Gully initiation occurs when the shear stress applied by runoff exceeds the strength of the soil surface on the hillslope. GRAIP computes the Erosion Sensitivity Index (ESI) (Istanbulluoglu et al. 2003), as shown below, at each drainage point.
